Viewpoint

Spring 2009

Found and lost

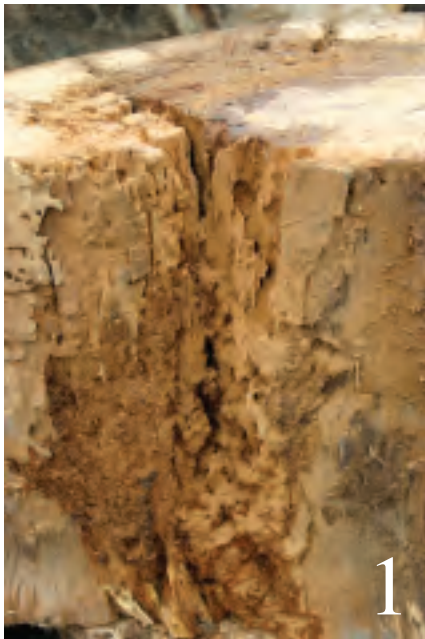
Photo 3 The Stag Beetle with sketch below.

Stag beetle (*Lucarnus cervus*)

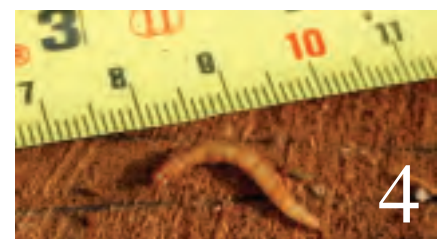
Photo 4 the Tenebrionid beetle with sketch below

Tenebrionid beetle (*Tenebrio molitor*)

Although mostly associated with timber in flour mills, this larva can also be found in well rotted timbers (as in photo 4). The tunnels are irregular oval or circular and about 10mm diameter, partially filled with coarse fibrous powder. The damage can be confused with death-watch or house longhorn, but unlike those beetles, no treatment is required for Tenebrionids other than the removal of the source of dampness. They will not attack sound timber. Careful investigation is therefore called for if unwarranted chemical treatment is to be avoided.
